## Reservoir Pitch Stone repair works

Macari Hill Civil Engineering (MHCE) were recently engaged by their client to complete pitch stone repair works to different areas Loch Glow Service Reservoir. The original pitch stone works had deteriorated over the years and required several repairs to maintain the integrity of the dam wall. Figures 1 and 2 show the extent of the repair areas.

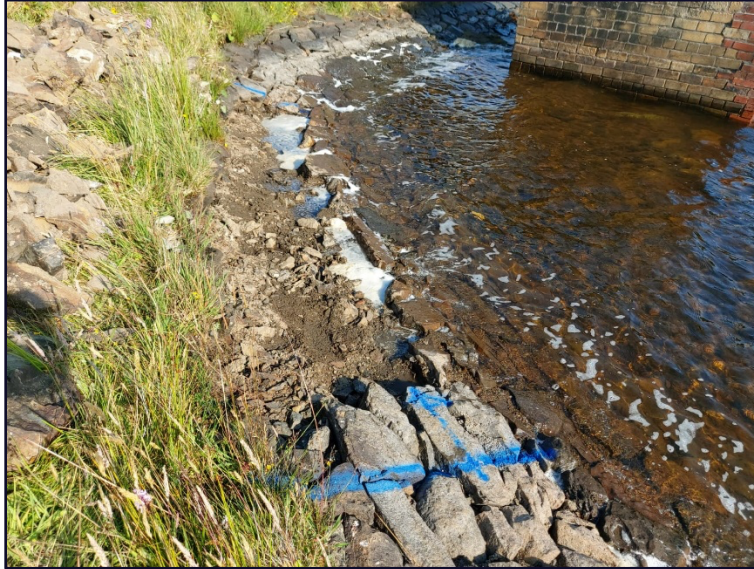
Fig 1. Existing pitch stones missing from the upstream reservoir wall.

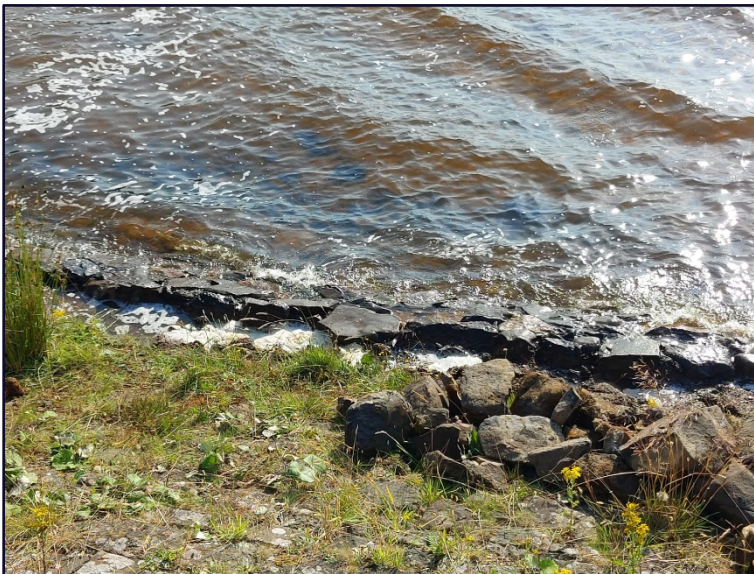
Fig2. The reservoir levels required to be dropped before repair works could commence.

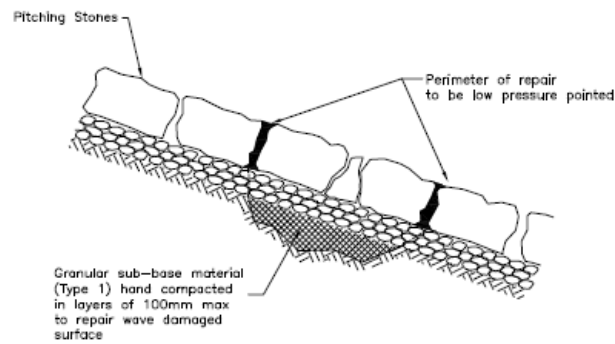
Repaired Area with Loss of Bedding

**Figure 3** Design Detail of pitch stone repair.

The designer provided a specification for the repair work which detailed the position of the new stones and materials to be used. See Figure 3

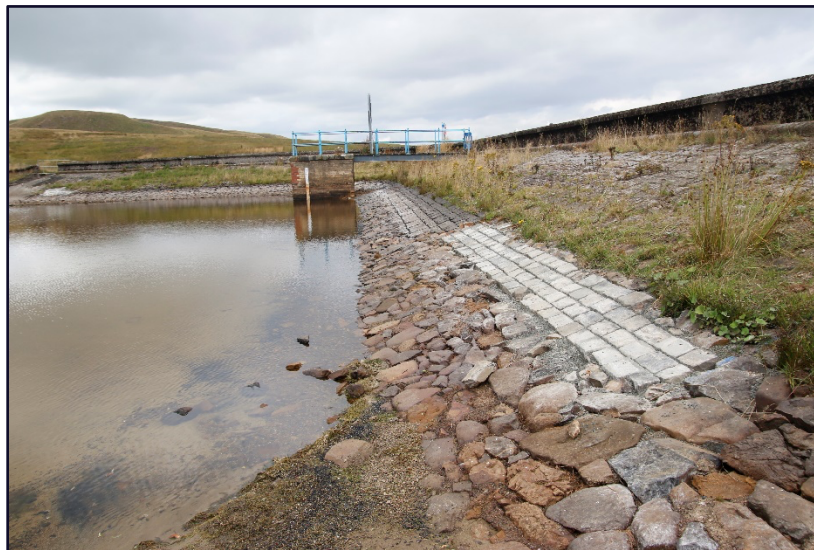
**Fig.4.** Reclaimed whin setts on east facing wall

Our client proposed to use stone from another site which would be delivered and broken to shape using an excavator and Hydraulic breaker. After conducting a site visit MHCE proposed an alternative to use reclaimed Whin Stone setts. This proposal was accepted eliminating the requirement for the additional plant. Due to the site being popular with anglers it reduced the noise disturbance to the reservoir users whilst also using a reclaimed material thus providing a more sustainable solution.

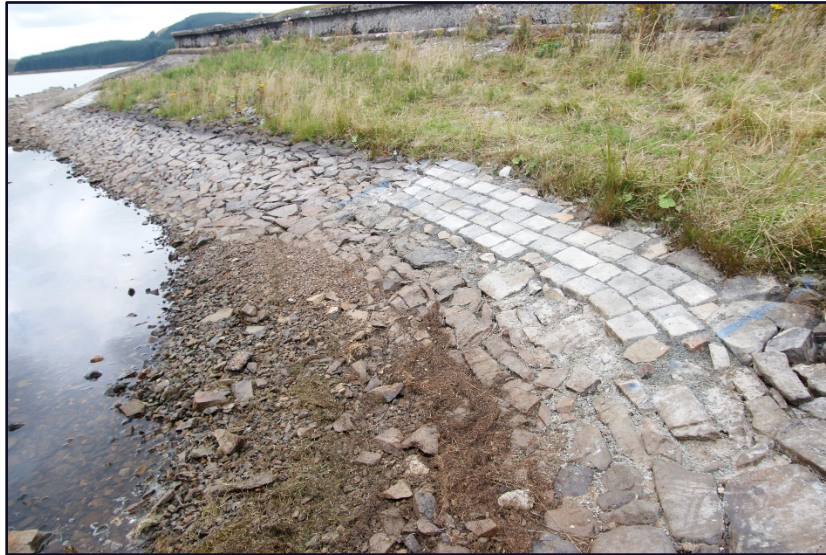
**Fig 5.** Reclaimed whin setts on North facing wall

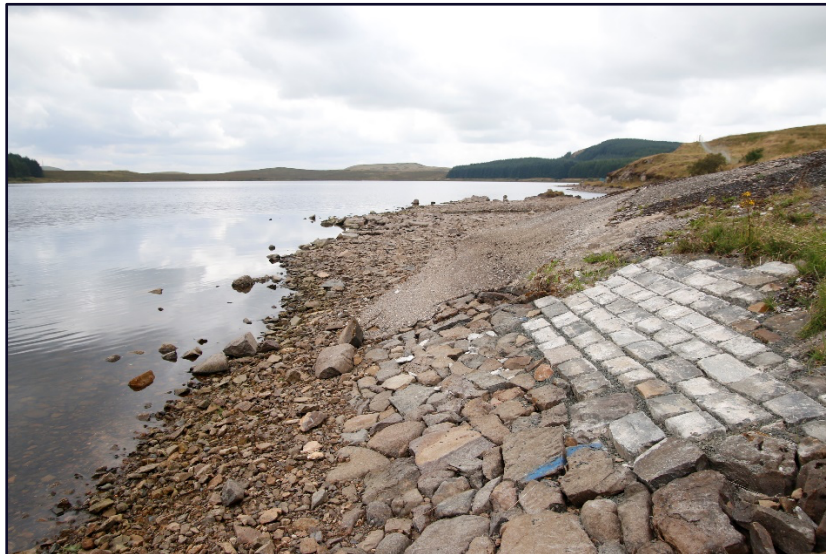
**Fig 6.** Reclaimed setts on north facing wall west of spillway entrance
