Drainage Case Study

Macari Hill Civil Engineering (MHCE) recently delivered a drainage package at a new mixed used Development, on the outskirts of Edinburgh. The works comprised of 160m of 225mm dia carrier/filter drain, Manhole construction and 25m of new foul sewer. In addition to this, the project remit also included remedial works to a pumping station which had been partially completed but was subject to severe water ingress. This case study highlights the details and challenges overcome whilst delivering this package of works.

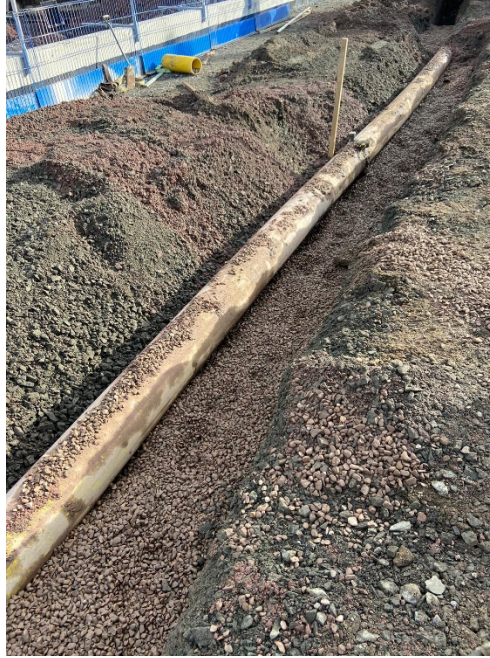
Fig.2 Medium Pressure Gas Main within excavation.

The new diversion comprised of both 225mm dia solid wall carrier pipe and 225mm perforated pipe within a filter trench. As well as the installation of 1200mm dia manholes at the start and end of the diversion, there were 4 no. 450mm dia catch pit inspection manholes installed on the line. The new diversion route needed to be constructed within the new services corridor. Due to the presence of a medium pressure gas main, which followed the same route of the storm water diversion, a substantial section of this needed to be hand dug (Fig.2)

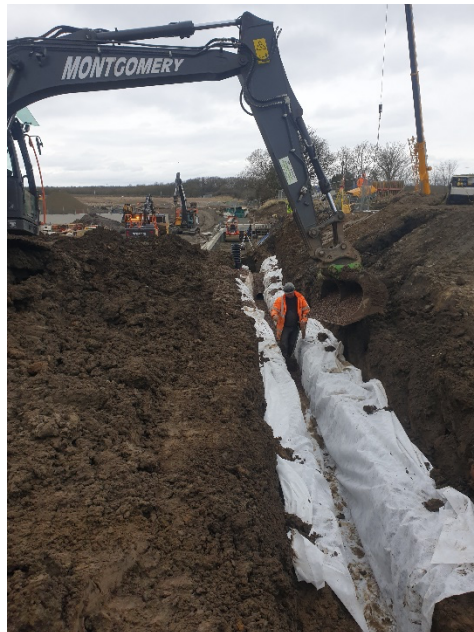
Fig.3 Laying bedding prior to pipe installation.

Once the 225mm carrier drain had been installed adjacent to the marina wall, the 225mm dia filter drain was then installed towards the start of the stormwater diversion see fig.3.

This section of filter drain still followed the line of the gas main. A disused field drain also encroached the excavation for the storm sewer. The excess ground water from this was managed locally with a 2-inch sub pump.

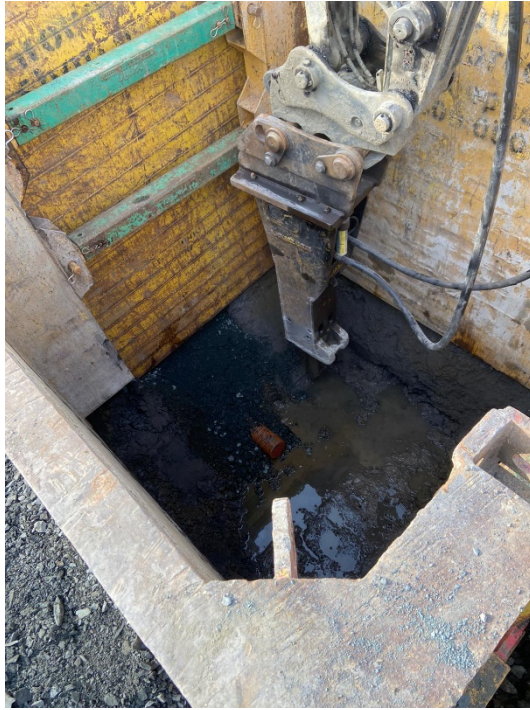
Fig.5 Pecker Attachment used to Break out rock.

Whilst excavating for the new foul manhole rock was encountered. This had to be broken out using a 20-tonne excavator with pecker attachment to reach invert level. Whilst doing this under pressure ground water entered the excavation. This was managed with pumps until concrete plug could be poured. The manhole was then constructed, and the excavation backfilled.

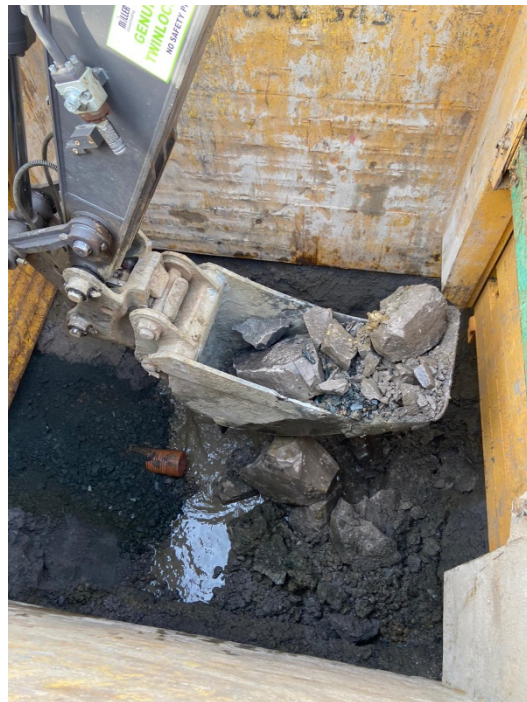
Fig. 6 Rock being removed from Excavation.

Rock was encountered for the first 6m of the 150mm dia foul sewer installation. A Sheets and frames solution was used to install the 150mm dia sewer beneath the gas main. The standard trench box was then used to install the remainder of the pipe.

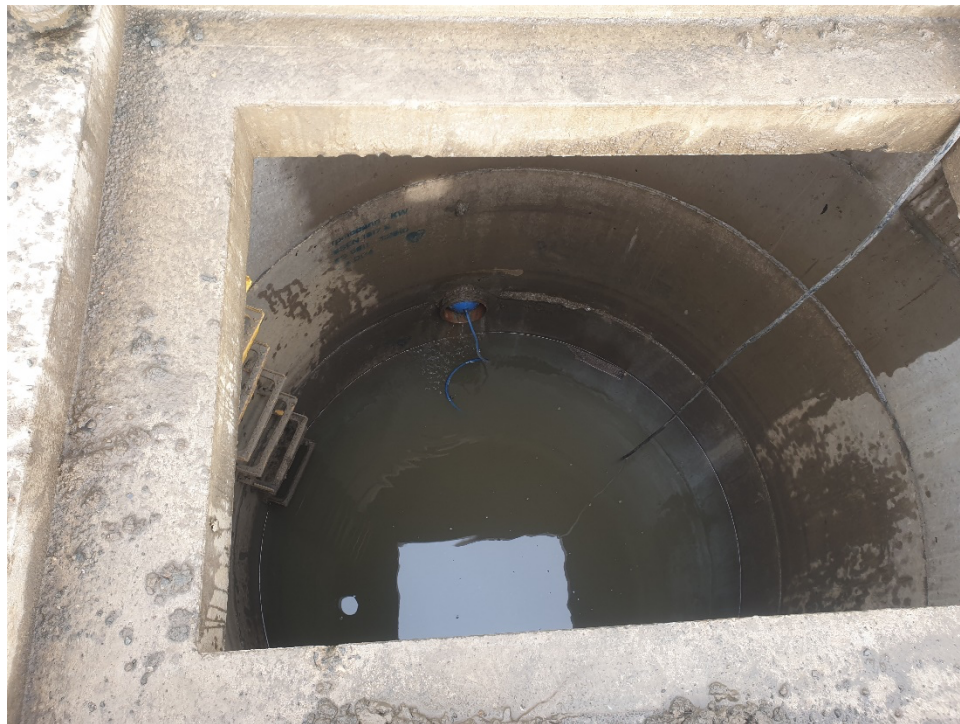
Fig. 7 Water ingress from underside of inlet pipe despite inflatable stopper being in place.

MHCE excavated down the outside face of the pump well and exposed the inlet pipe. A 4-inch hydrainer pump was then installed within a sump and used to lower the ground water level. The pipe was then inspected which confirmed that the stub pipe had not been sealed properly on the outside of the chamber. A shutter was then built, and concrete was poured and poked ensuring a good seal to the pipe.

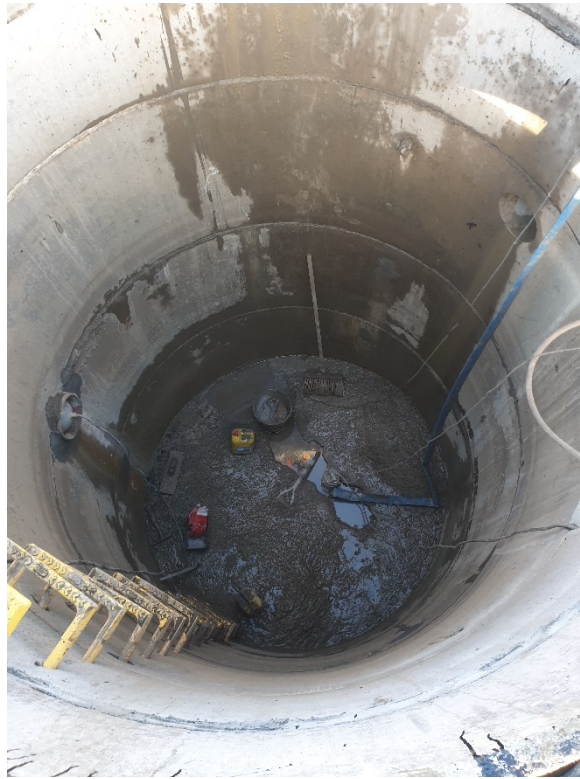
Once this had been completed the pump well was pumped out so the base could be inspected. This inspection confirmed that the previous attempt at forming the conical shape to the base of the pump well had not succeeded (fig.8). MHCE proceeded with breaking out the surplus concrete.

Fig.8 Surplus concrete to be broken out.

Once broken out, MHCE then poured the base of the pump well to the correct invert level. The base was then levelled off ready for the M+E contractor. MHCE then levelled and orientated the pumping station cover slab to ensure the M+E contractor could properly plumb and install the pump guiderails and duck foot bends on the base of the pump well.

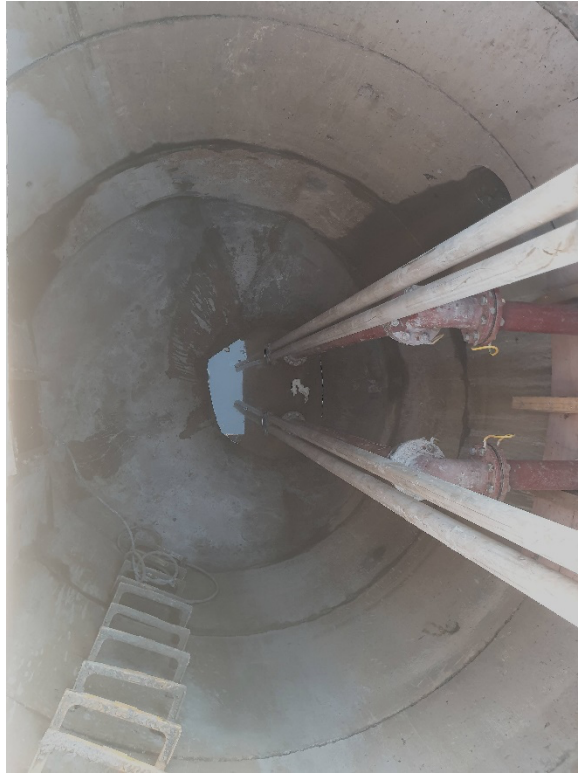
Fig. 9 Granolithic benching complete and pipe work installed.

MHCE then formed the 60° conical benching shape using S1 slump concrete and finished it with a 50mm thick granolithic finish. Once the pipe work was set and tested by the M+E contractor, MHCE shuttered the inside wall of the chamber where the pipework exits the well and poured concrete to seal the penetrations.

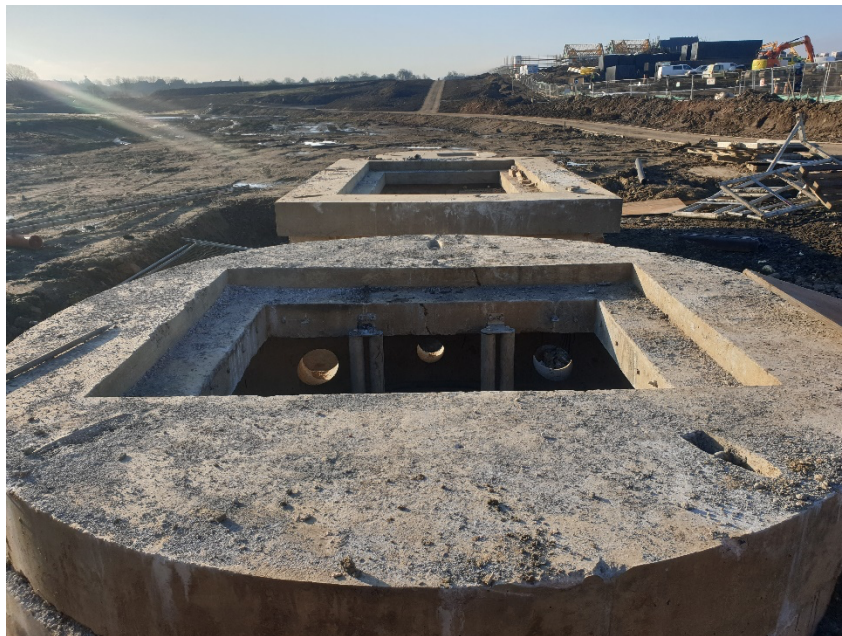
Fig10. Cover slab set to correct orientation and pump guiderails installed.
